# Service Advisory: Evolution Series Impulse Drive Gearbox Seal Leak MGET10-7202022US

July 19<sup>th</sup>, 2022- This Service Advisory is to notify our dealer network of a field issue being reported on Evolution series units (EVO, Rival, Vanquish) with build dates of November '21 – MAY '22. This issue is specifically regarding the Impulse Drive Gearbox leaking oil around the main hub ring. This is an arbitrary issue. If the mower has run in the field for 10+hrs and has not experienced a leak, this advisory likely does not pertain. Please see below.

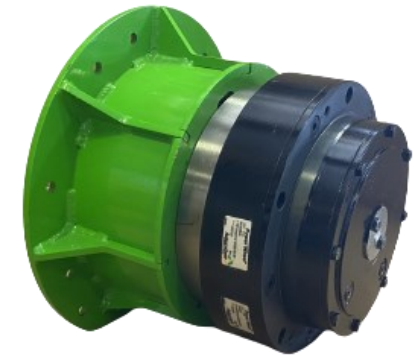
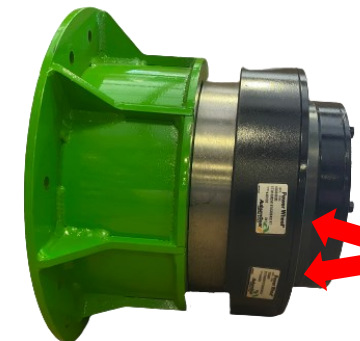
**Figure01**

**IF OIL IS FOUND** - Please contact MeanGreen Service ( [servicecenterinfo@meangreenproducts.com](mailto:servicecenterinfo@meangreenproducts.com) ) with the serial number of the unit along with supplied pictures of the supplier tags located on the gearbox (removal of the wheel is required to access stickers- see **figure01** ).

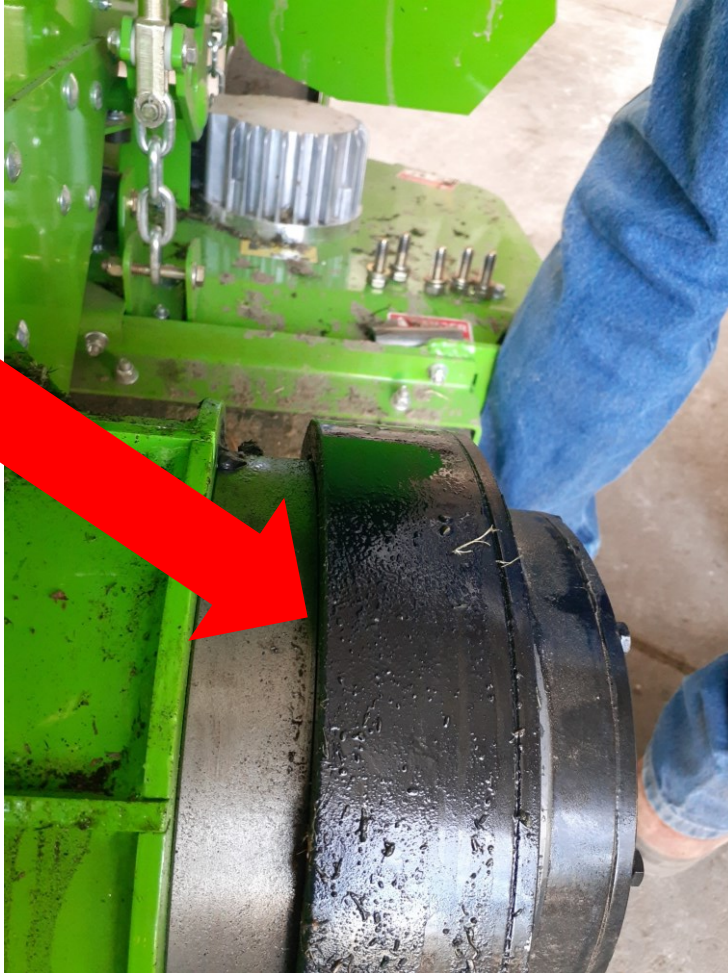
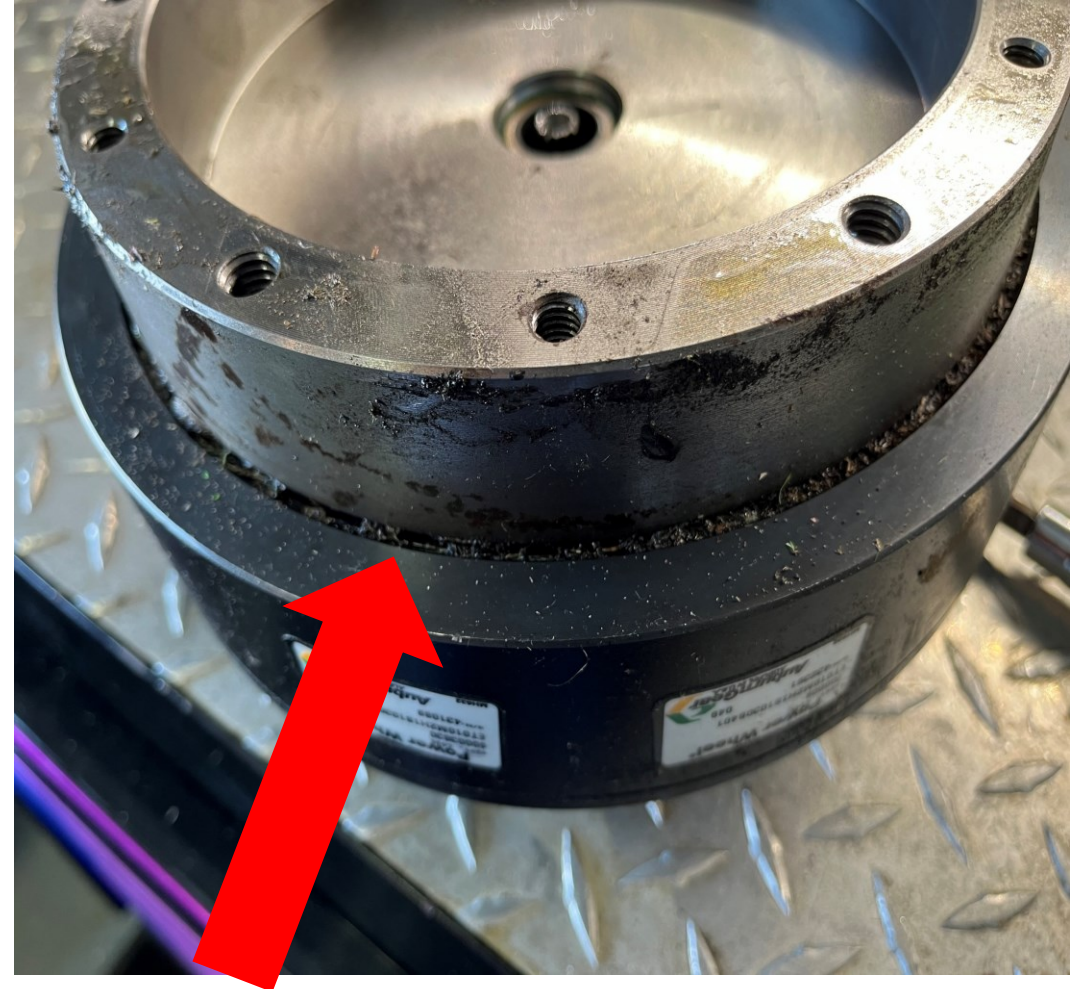
**What is the issue?:** Impulse Drive Gearbox leaking oil around the main hub seal with less than 10hrs of use

**What should you do?:** Visually inspect the inside hub of each wheel, on each unit in question. Inspect the Inside hub lip of the gearbox for oil residue.

Leaking Hub Seal Location

Once MeanGreen Service has approved the unit for repair, please place a PO for Part # **MGCORE363**. The part will be purchased as a core charge and will be swapped out for a new gearbox. The leaking unit(s) is **REQUIRED** to be return to MeanGreen. A return label will be issued upon request. ( Send PO to : [Parts@Meangreenproducts.com](mailto:Parts@Meangreenproducts.com) )

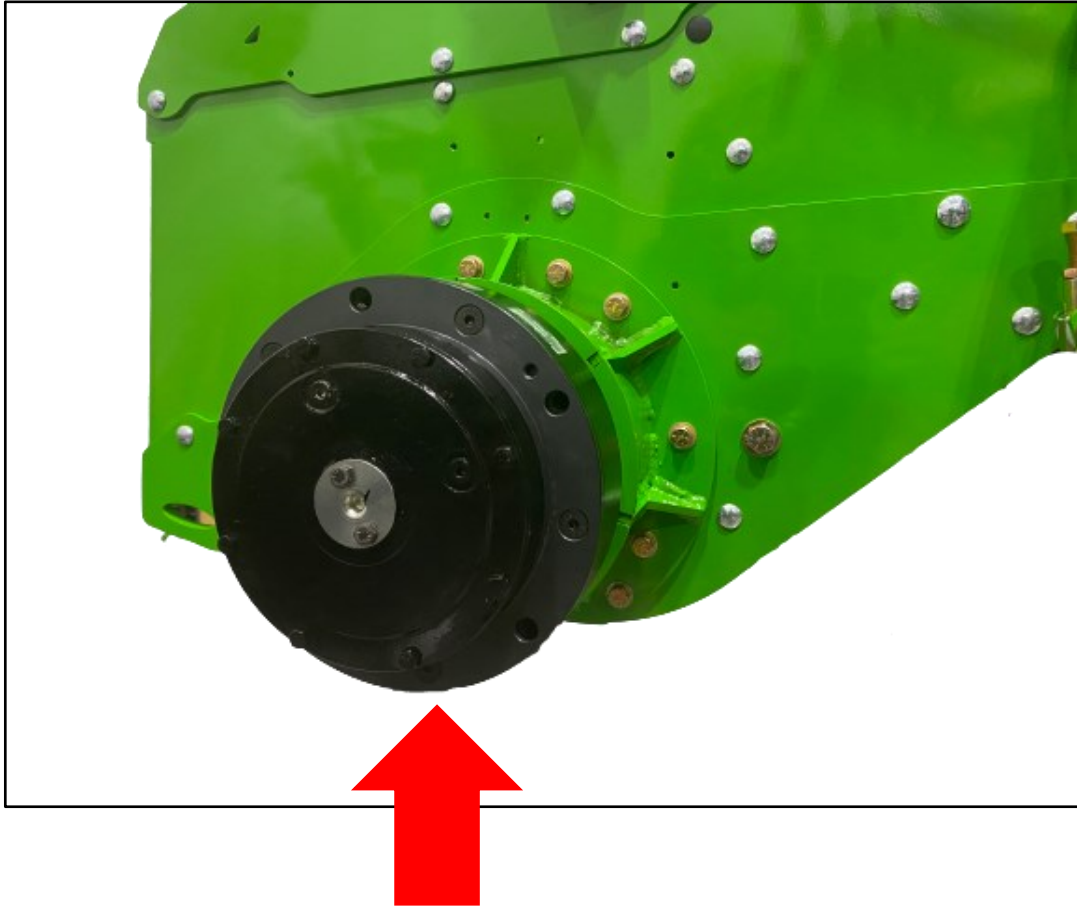
**Figure-02:** Place a Hydraulic Jack under this area of gearbox OR use an engine hoist with a strap around the gearbox.

- **\*\*\*CAUTION!!\*\*\*** These complete units weight upwards of 70lbs. Place a hydraulic jack under the hub or use an engine hoist, prior to removal of the last bolt, to safely lower the unit to the ground. See [Figure-02](#) for Reference points for hydraulic jack.
- There are 4 through-bolts (bottom section of the can) and the remaining are installed with Cage-Nuts

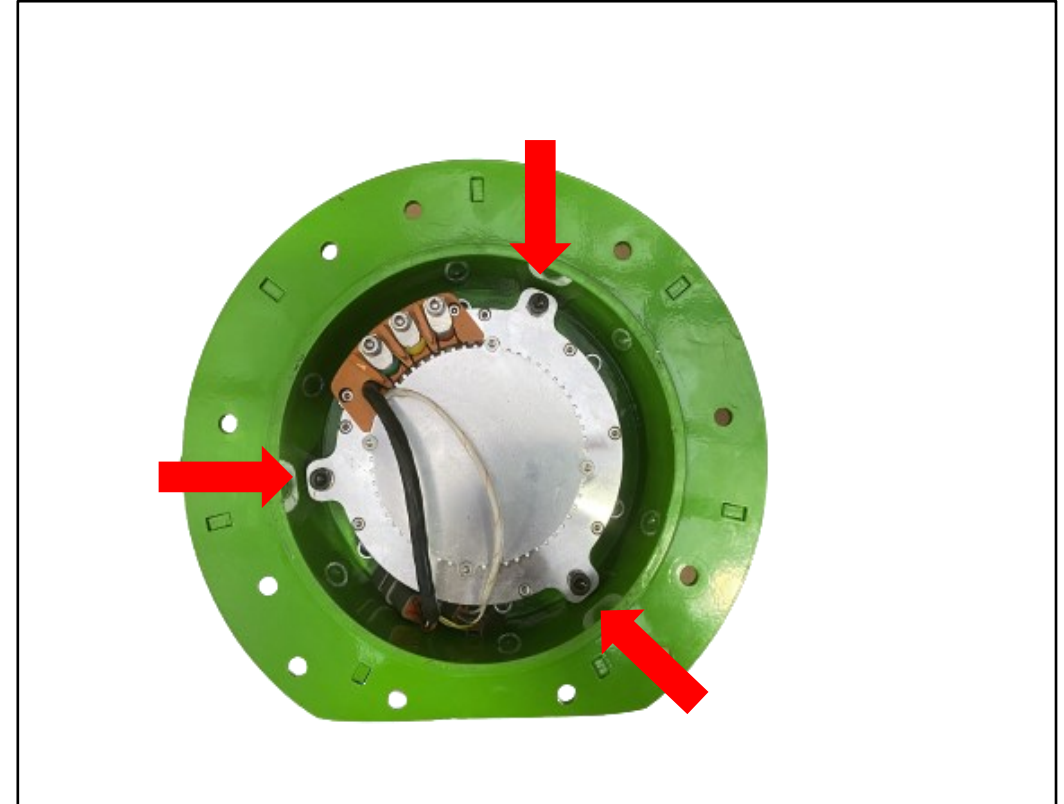
**Figure-03:** Remove the (3) Allen head bolts holding the motor to the gearbox. Remove Motor from Gearbox.

**Step 5:** Once the drive is safely removed, Remove the 3 Allen head bolts holding the motor to the gearbox (See [Figure-03](#) )

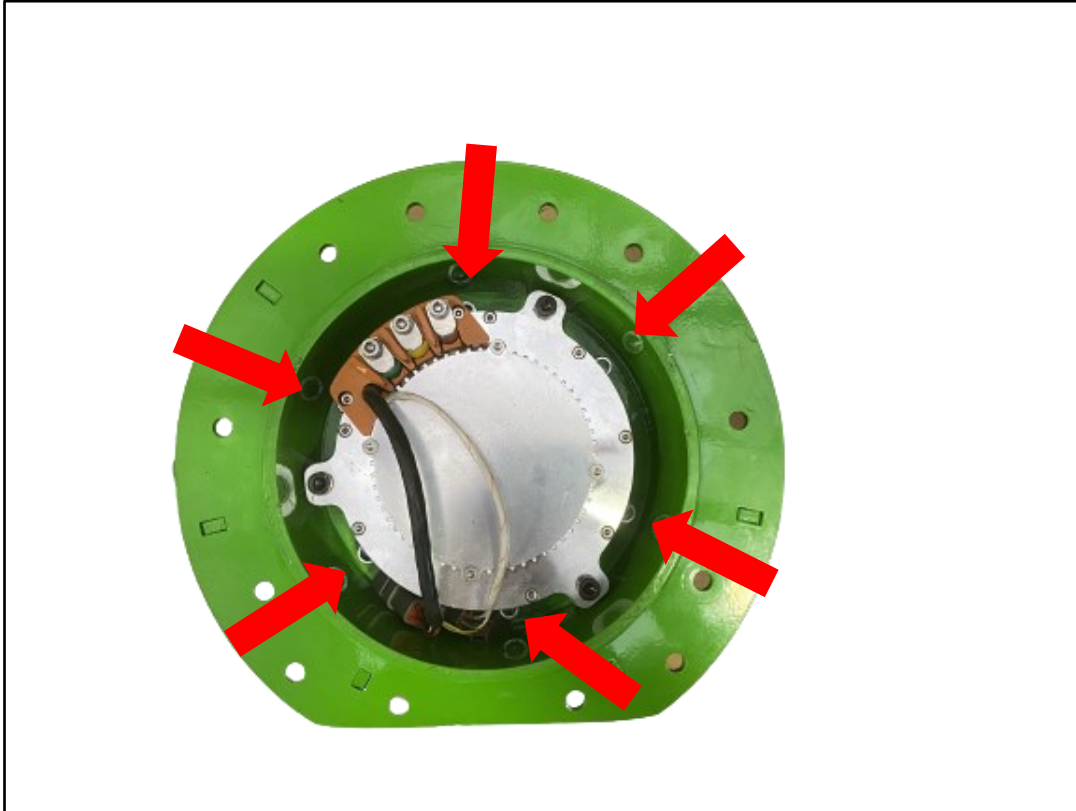
**Figure-04:** Remove the (6) Allen-Head Bolts holding the gearbox to the green can. This will be easier to access once the motor is removed in previous step.

**Step 7:** Unbolt the Gearbox from the green drive can (See [Figure-04](#) )
